PINE RIDGE/ WAPITI RIM COMMUNITY ASSESSMENT

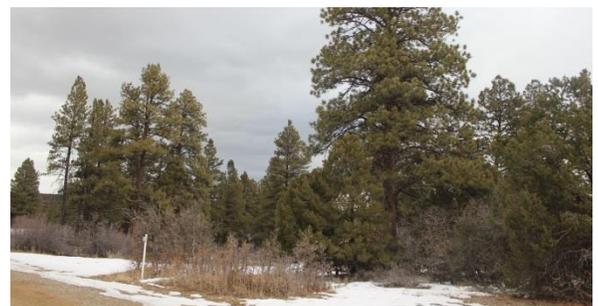
Dense canopy drops down into the side canyon between Roads 35 and 35.3.

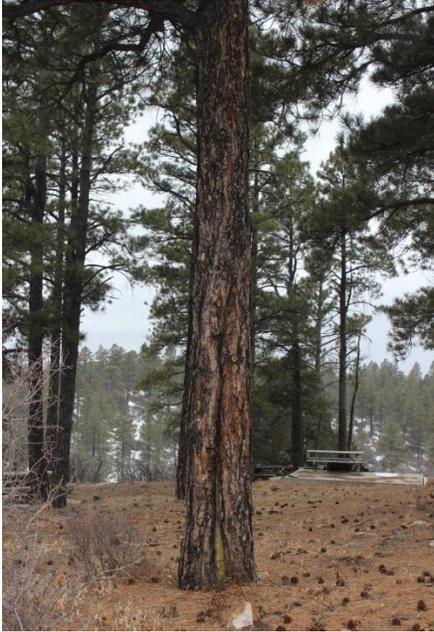
Lightning struck tree in the defensible space zone of a home in this community.

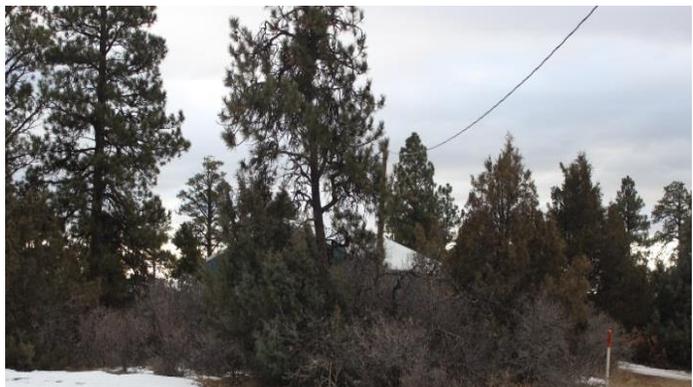
Dense pockets of vegetation are characteristic along roadways.

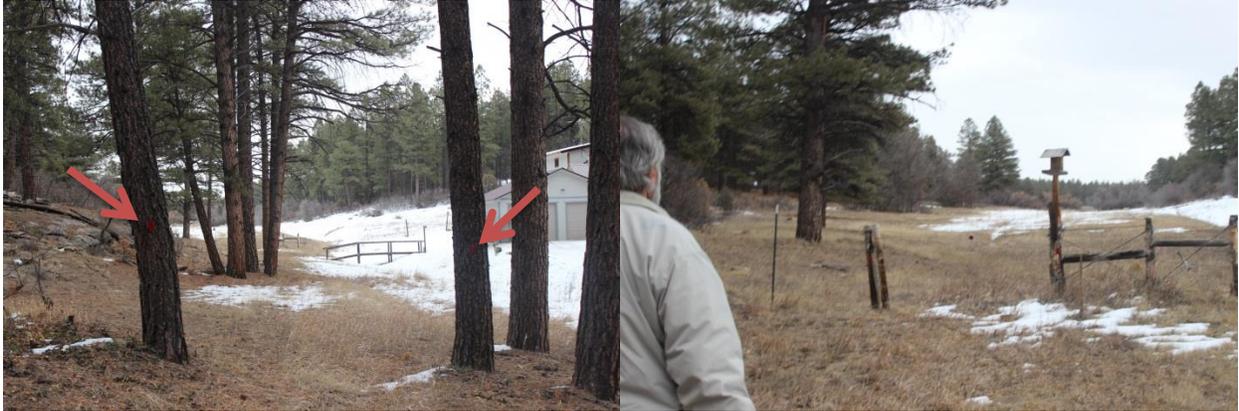
Secondary egress marked with red reflectors.

Canyon bottom could serve as safe area if mowed or grazed.

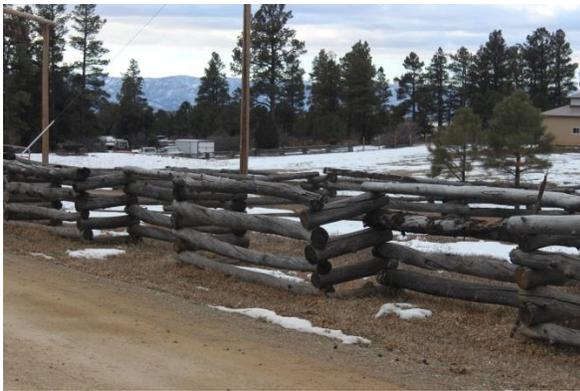
A section of log fencing could become heavy fuel along an otherwise safe section of the road if the grass gets tall. There are many wood fences throughout the community.

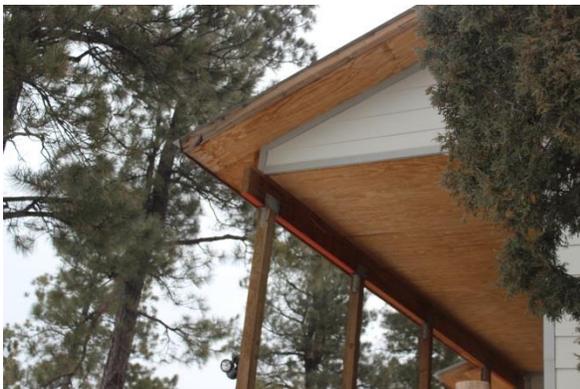
Exposed plywood beneath porch eaves.

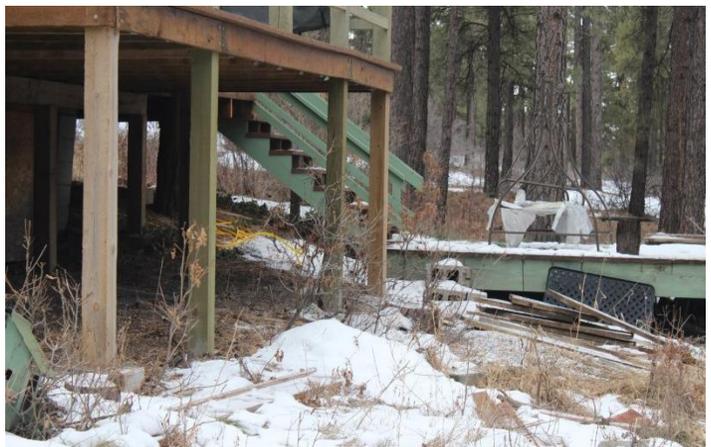
Exposed composite wood product skirting and accumulated fine fuels beneath wood deck. Wood decks are common.

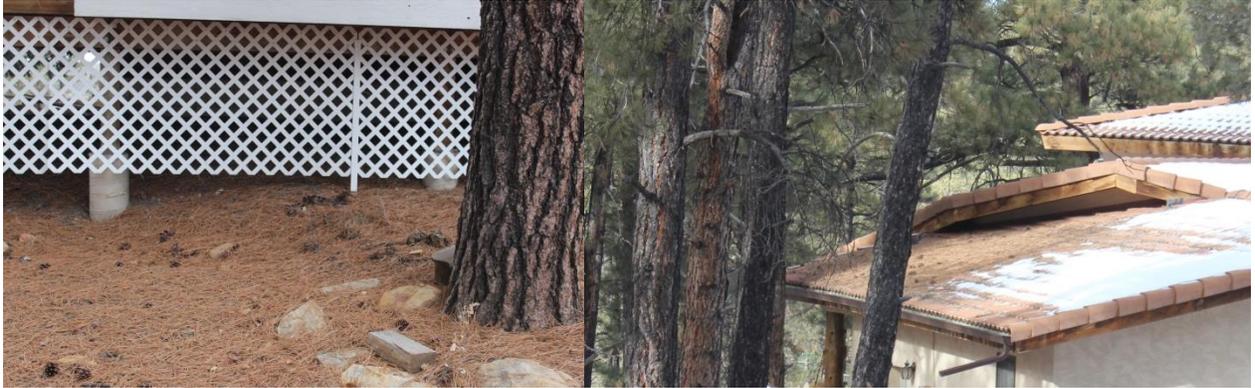
Decks are not adequately enclosed or screened.

Needles accumulate around and on homes with many trees within what should be Zone 1 Defensible Space.

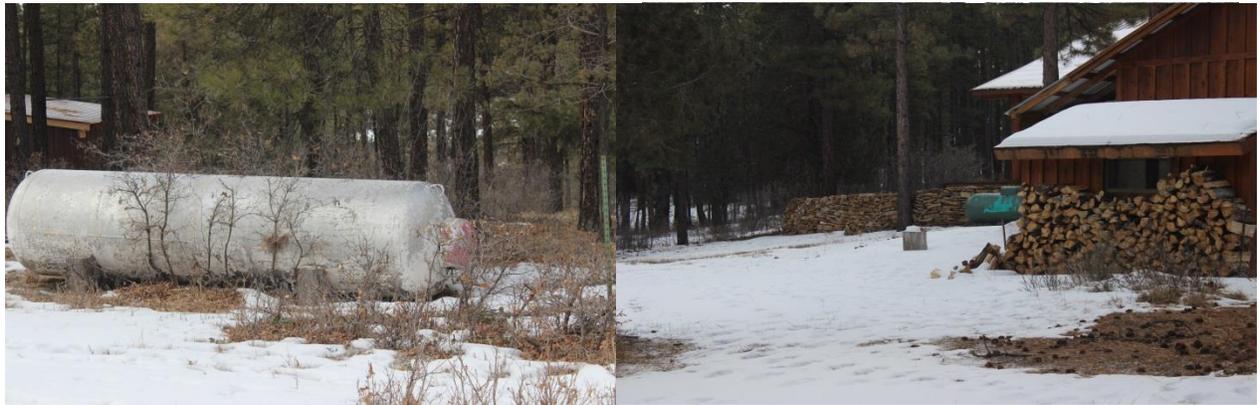
Most propane tanks are located a 'safe' distance from the home, but this one may be at risk from surrounding vegetation.

Though this photo was taken in winter, not all homeowners remove excess cordwood stacked against the house once the wood burning season is over. Also note the stone wall in the background. This stone wall makes an excellent fuel break for the main structure.

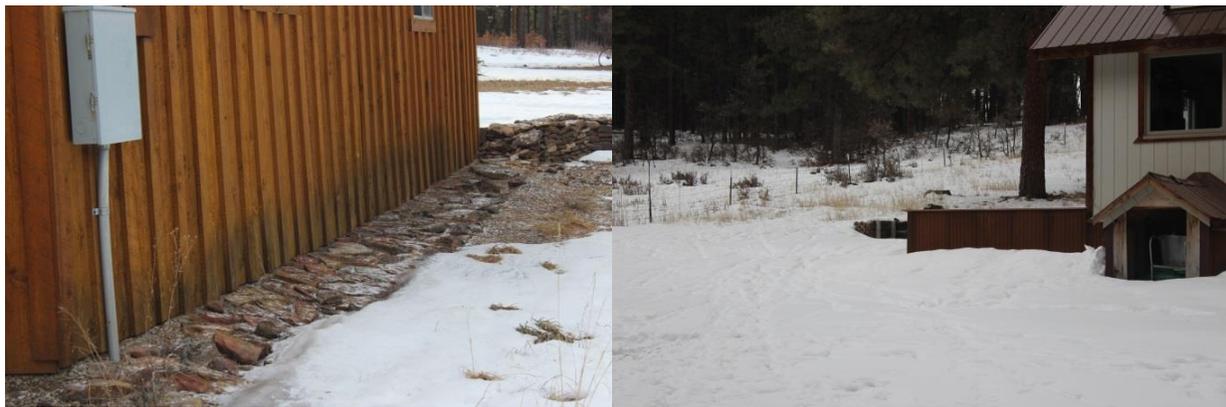
Garage skirting with stone will help building resist fire approaching on the ground.

Corrugated tin wainscoting and propanel roof help harden this home.

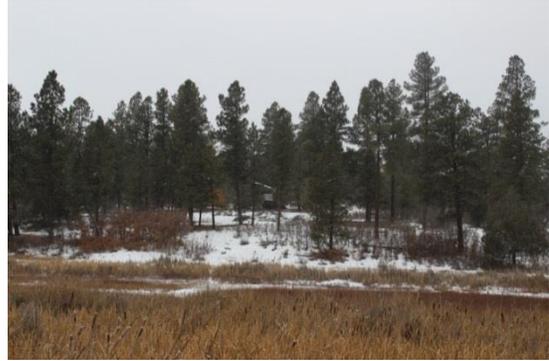
Pre-settlement density of the Ponderosa Pines was about 1/10th of what it is in this neighborhood today. Only a few trees should be kept in first 30' from house. See the house on the right? Before forest thinning and extensive oak mitigation in 2013, this new home on the right couldn't be seen from the reservoir. A good defensible space doesn't mean getting rid of the forest.

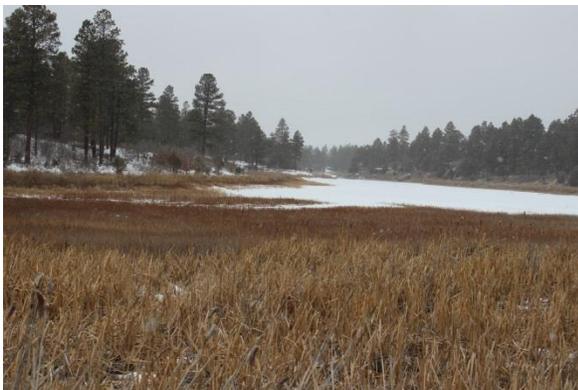
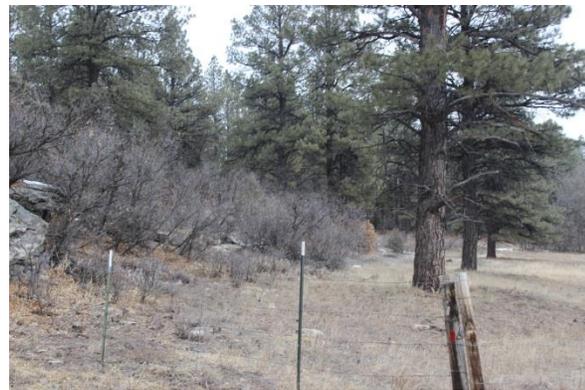
Two of the four potential safe areas, the one at the mouth of the Lost Canyon tributary, and the one west of Road 35, are regularly mowed by the homeowners. These photos show the edges of the other two potential safe areas. Adjacent forest would need to be thinned, and riparian vegetation would have to be burned off or thinned. The grassy areas for the safe zones would have to be maintained. The area at the end of R.6 belongs to a property owner to the east, outside of the community boundary.

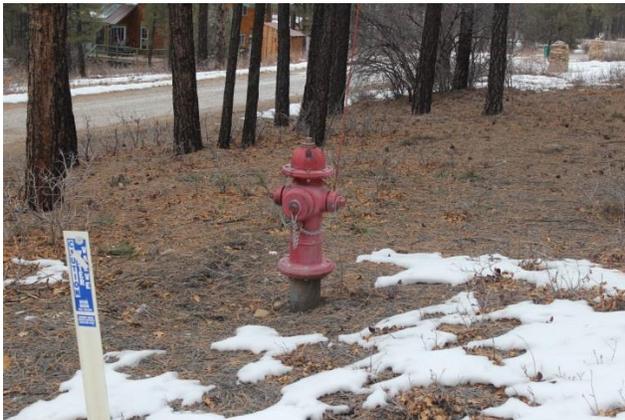
Water hydrants only functionally serve as water line clean-outs. The fire district shuttles tankers filled in town or at the Summit Lake Church to provide continuous water for suppression. Lost Canyon Reservoir could serve as a local source to draw water from, but the Fire Department access to the reservoir needs to be re-secured.
