# **Electra Lake Sporting Club**

# **Community Wildfire Risk Assessment**

**Completed August 26th 2019**

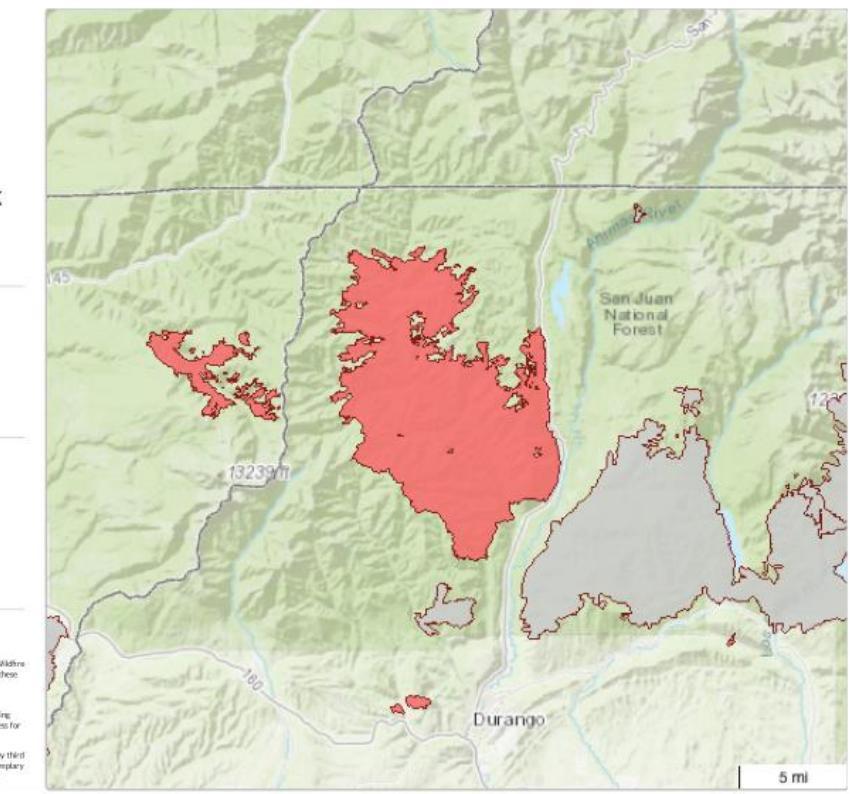
#### Electra Lake Historical Fire Map

Wildfires in this area of Colorado are common occurrences due to the relatively arid climate and low average rainfall. Due to historic fire suppression practices, this area has a significantly high fuel load and an overabundance of many species, predominantly pine, spruce, and oak. These factors contribute to a high level of fire risk for the area. While no major fires have occurred within the community, two major wildfire events have occurred within close proximity to the community in the last 20 years. The Missionary Ridge fire occurred approximately 12.5 miles south of the community in 2002, burning over 71,000 acres, resulting in one death and the loss of 46 structures. in 2017 there were at least 3 lightning strike fires that started within the community. Quick response by Bob Haines, Caretaker for the Electra Lake Sporting Club, and firefighters from Durango Fire ensured none of these fires grew to larger than 1/10<sup>th</sup> of an acre in size. The other major wildfire event was the 416 Fire in 2018, occurring on the west side of Highway 550 opposite from the community. This fire burned a total of 54,000 acres with no structures lost. Due to the extreme fire conditions in 2018, the San Juan National Forest Closed under Stage 3 Fire Restrictions for the first time in the history of the forest.

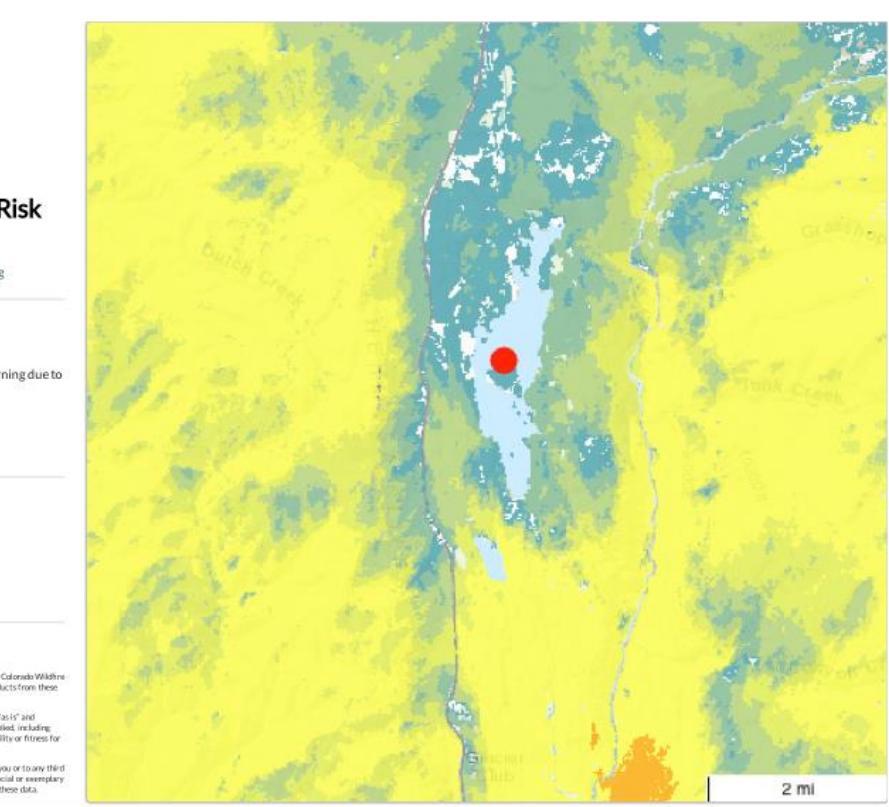
#### **Burn Probability**

Annual probability of any location burning due to wildfire.

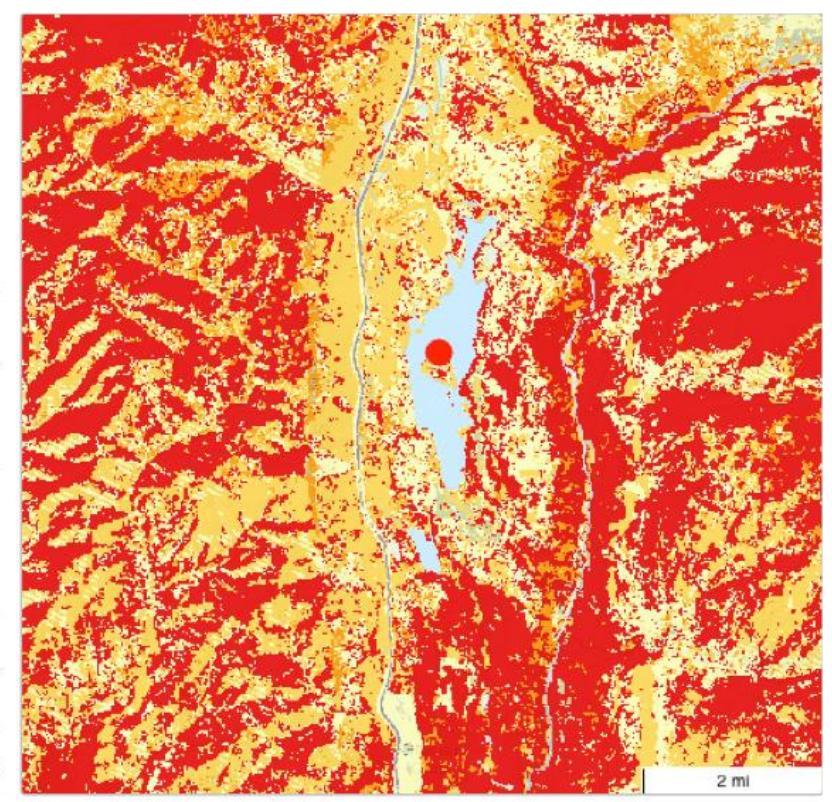
#### Fire Intensity Scale

Quantifies the potential fire intensity by orders of magnitude.
