THE RANCH

COMMUNITY WILDFIRE RISK ASSESSMENT

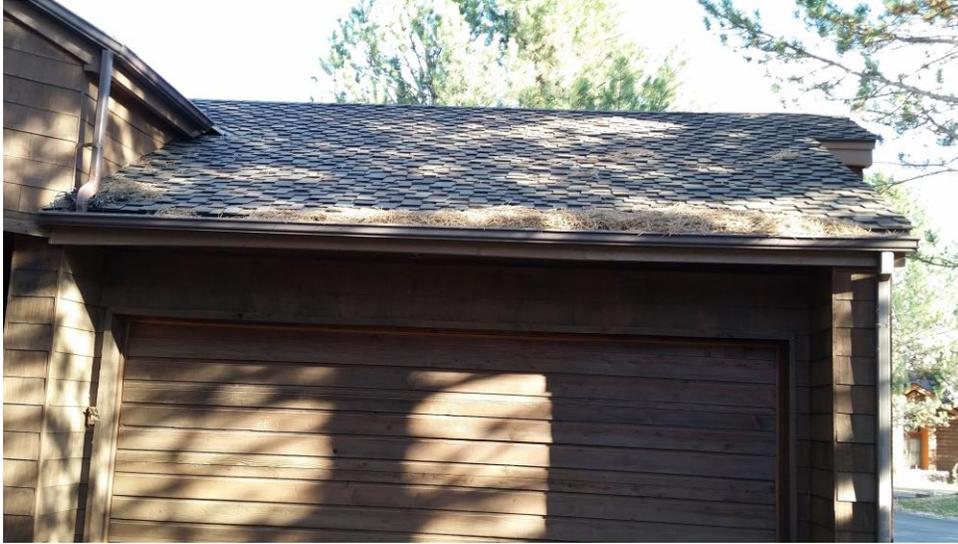
Due to extensive, well-mowed grass in the neighborhood the likelihood of surface fire spread is slim. The most likely source of fire spread would be from a house fire where flying embers drop onto nearby combustible materials on an adjoining home. The same scenario could play out if there was a crown fire burning on the San Juan National Forest, especially to the west of the community, and sparks and embers landed on shake shingle roofing and combustible materials near homes; burning embers from the Missionary Ridge and Valley fires in 2002 rained down on The Ranch. The large, broad tree crowns could provide a good vector for fire spread among often-closely spaced structures. While embers are most likely to ignite a home, trees could easily carry fire from structure to structure.

Trees overhanging homes also drop needles which can accumulate on rooftops and in gutters. The roof edge is a particularly vulnerable part of most homes.

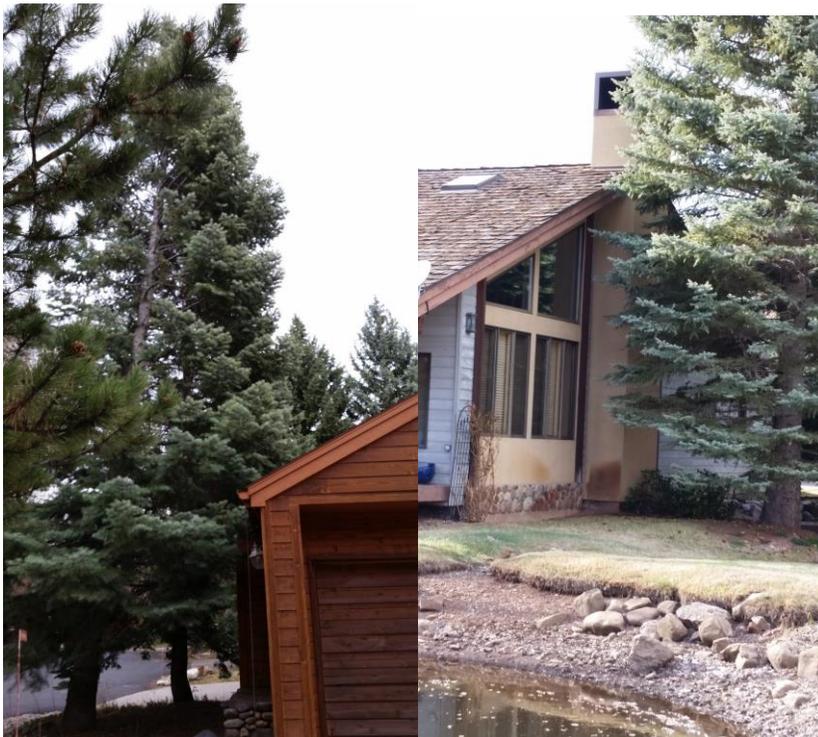
Figure 1Left: Though trees are well irrigated and construction details include a stone barrier adjacent to the wood siding, gutters trap needles from nearby and overhanging trees, leaving this garage particularly vulnerable at its eaves. Right: This home has decent defensible space, but is extremely vulnerable due to its shake shingle roof.

- HOA replace wood shake roofs on mail house and pump house/storage shed
- Strongly encourage homeowners who still have wood shake roofs to replace them as soon as is financially possible
